**Flood Control Project Maintenance
Levee Inspections**
LMA District Cover Sheet
Spring 2017 Levee Inspection Results

Reclamation District No. 0563 Tyler Island

Unit Cover Sheet

| Waterway | | | Bank | Unit Miles |
|---|---|---|---|---|
| Unit No. 01 Georgiana Slough (Tyler Island) | | | Left | 12.11 |

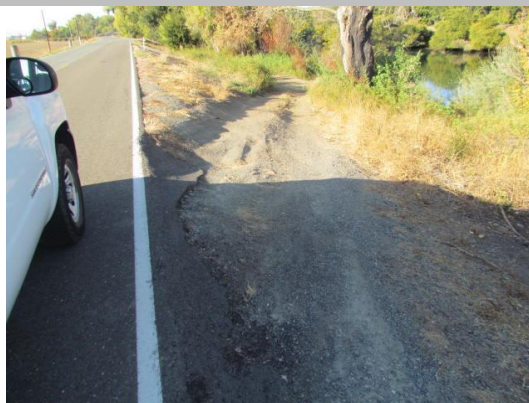
Photo 1 of 1 : SP_2017_RD0563_210_16_20170313_00016.jpg

| Slope damage is due to fishermen vehicle traffic. | | | | | |

Looking southwest at slope damage caused by vehicle traffic.

| S3 : Repair the levee slope damaged by vehicle traffic and prevent access where possible. | | | | | |

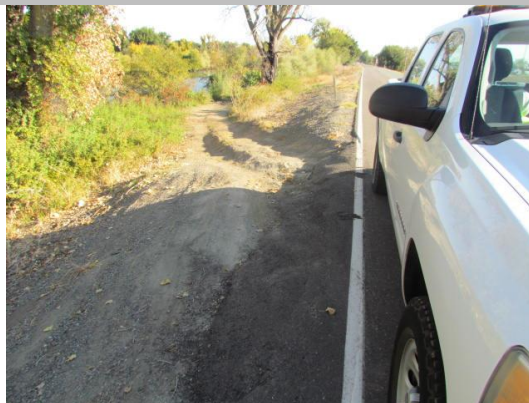
Photo 1 of 1 : SP_2017_RD0563_210_26_20170313_00022.jpg

| Slope damage due to fishermen vehicle traffic. | | | | | |

Looking northwest at slope damage caused by vehicle traffic.

| S3 : Repair the levee slope damaged by vehicle traffic and prevent access where possible. | | | | | |

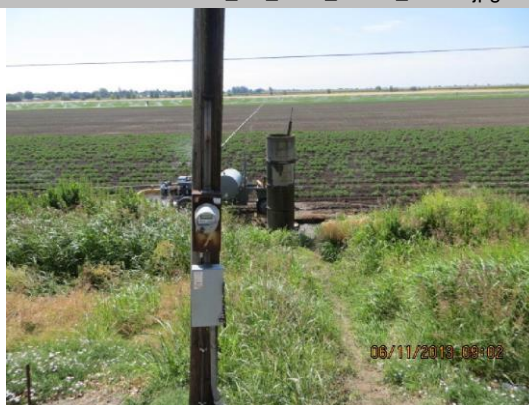
Photo 1 of 3 : UCIP_SP_2017_14866_24508.jpg

| FS_ID:14866 DS_ID:20130 EP_NO: 11218 Repair Type: Non-Urgent Crossing Status: Found UCIP Comments: Pipe leaking at various points on WS berm. Failure on berm may indicate potential for failure within the levee. Good candidate for video inspection. FIELD_STRUCT_DESC: 12-inch steel pipe through the levee 5.0 feet below the crown. Walkway to pump on pile structure in stream. Siphon breaker in a 24-inch CMP riser on the waterward shoulder. 1" air and vacuum valve and a 15' tall by 36" diameter concrete standpipe at the LS toe (ABO No. 11218, 1975). Originally included in the 1954 O&M manual. FS Date: 6/11/2013 | | | | | |

JP on LS slope with 36-inch concrete standpip on LS toe.

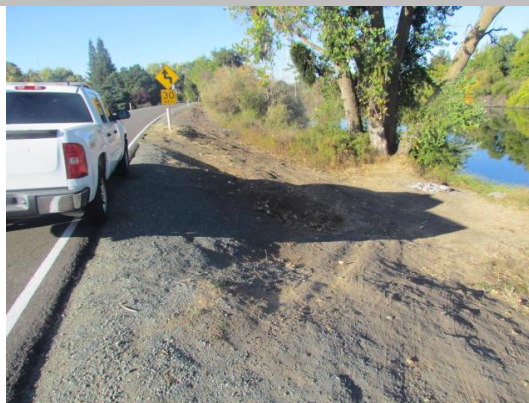
Photo 1 of 2 : SP_2017_RD0563_210_143_20170313_00127.jpg

| Slope damage due to vehicle traffic. | | | | | |

Looking southeast at slope damage on waterward slope.

| S3 : Repair the levee slope damaged by vehicle traffic and prevent access where possible. | | | | | |

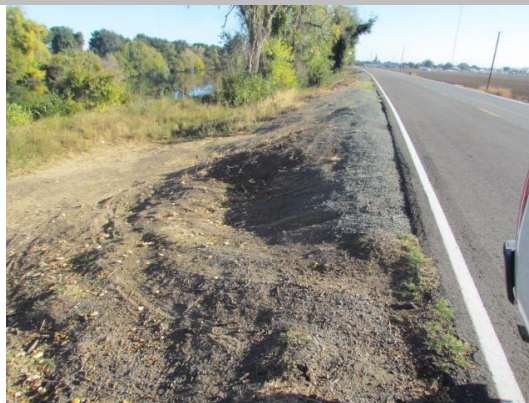
Photo 2 of 2 : SP_2017_RD0563_210_143_20170313_00128.jpg

Looking northwest at slope damage on waterward slope.

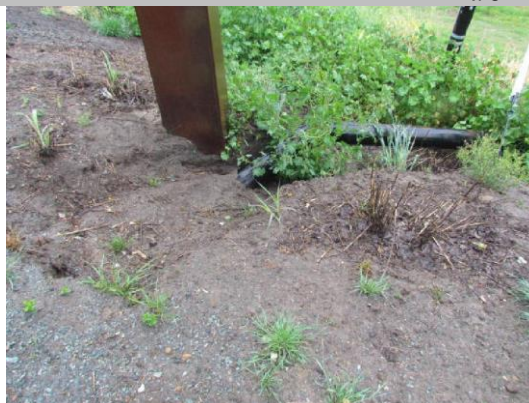
Photo 1 of 1 : UCIP_SP_2017_51627_76994.jpg

| FS_ID:51627 DS_ID:25486 EP_NO: N/A Repair Type: Non-Urgent Crossing Status: Found UCIP Comments: 04/20/2017 Slight depression above pipe near landside shoulder as per DWR inspector Richard Willoughby, as noted during his Spring 2017 inspection. (K. Fazel - UCIP) FIELD_STRUCT_DESC: 6-inch externally-coated steel irrigation pipe, 3 or 4 feet below the crown. Pipe is likely a replacement for the 12-inch at this location under DSID 20131. Pipe is not permitted and found by DWR inspector Richard Willoughby during Spring 2017 inspection. FS Date: 4/20/2017 | | | | | |

View of newly installed steel pipe and depression above it. Photo courtesy of Richard Willoughby.

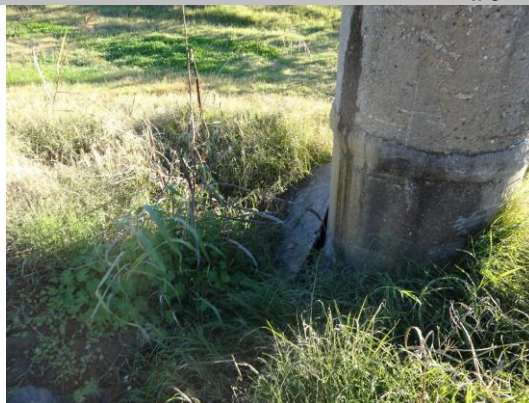
Photo 2 of 3 : UCIP_SP_2017_51626_76820.jpg

FS_ID:51626
DS_ID:20131
EP_NO: 11203
Repair Type: Urgent
Crossing Status: Found
UCIP Comments: 12/02/2016 Same as last inspection signs of leak are still present on both LS and WS. Recommend internal inspection of the pipe integrity though the levee to determine cause of depression on levee (either leak or poor compaction). Pipe debris previous noted on WS has been removed. (O. Magana - DWR UCIP)06/11/2013 Signs of leak in pipe at levee slope on both LS and WS where pipe enters levee. Moist soil at LS toe indicates possible internal leak. Evidence of recent pipe repair on WS. Pipe debris on WS toe should be removed. (W. Wylie - DWR UCIP)
FIELD_STRUCT_DESC: ** 12-inch steel irrigation pipe through the levee, 5 feet below the crown. Slant pump located on the waterside (WS). Siphon breaker and switch box also located on the WS slope. Service pole is located on the landside (LS) slope. (12-inch pipe authorized under Automatic Board Order (ABO) issued as Permit No. 11203, 1971 - Delta Farmers, Inc.) This crossing has been replaced with 6-inch under DSID 25486, as reported by DWR inspector Richard Willoughby during his Spring 2017 inspection. [Additional Reference(s): DWR Levee Log, 2005. USACE Sacramento O&M Manual Unit 103, June 1954 (HLM 0.73)]

Minor leaks visible on concrete standpipe.

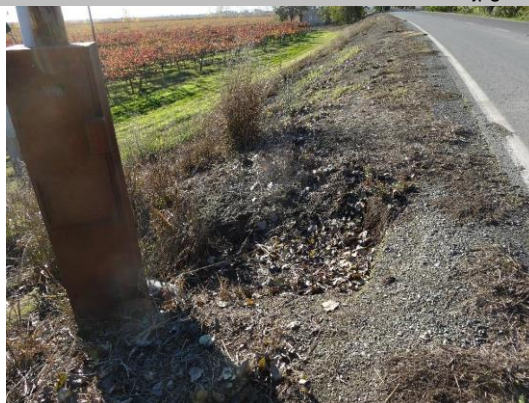
Photo 3 of 3 : UCIP_SP_2017_51626_76826.jpg

Subsidence visible on LS shoulder.

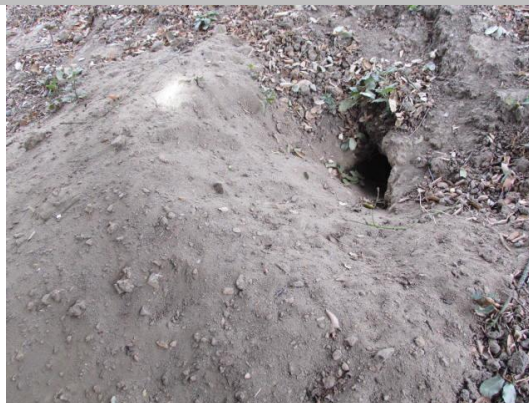
Photo 1 of 1 : SP_2017_RD0563_210_153_20170313_00134.jpg

| Several large to medium rodent holes noted. | | | | | |

Looking at typical view of several rodent holes on landward slope.

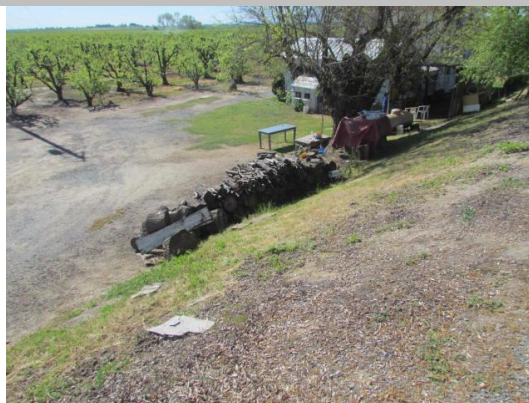
Photo 2 of 2 : SP_2017_RD0563_210_134_20170313_00110.jpg

Looking southeast at firewood at landward toe. (Spring 2016)

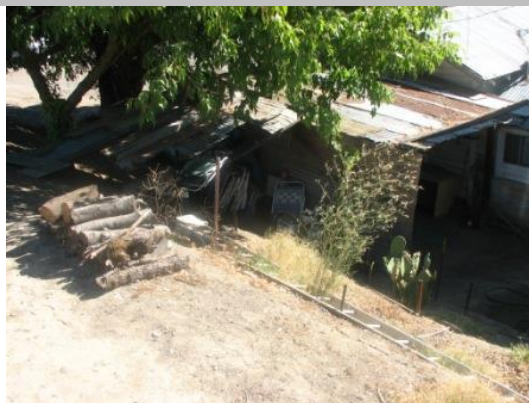
Photo 2 of 2 : SP_2017_RD0563_210_57_20170313_00046.jpg

Looking at a shed at landside toe.

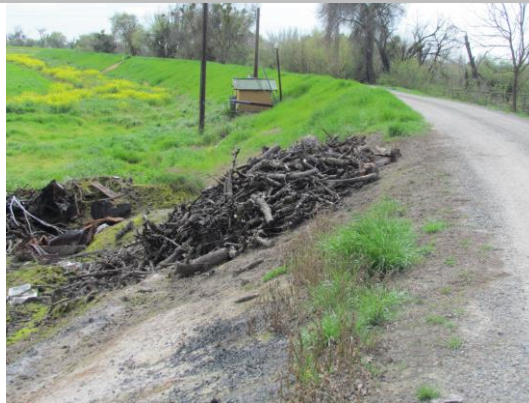
Photo 1 of 2 : SP_2017_RD0563_210_96_20170316_00243.jpg

| Pruning pile at landward toe. Landowner has burned pile, but pile is still within right away. | | | | | |

Looking downstream at prunings on landward slope. (Spring 2017)

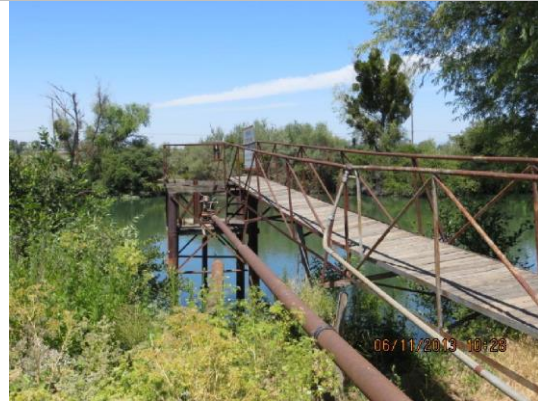
Photo 1 of 3 : UCIP_SP_2017_51449_24537.jpg

Pump on pile structure with walkway structurally failing. WS berm.

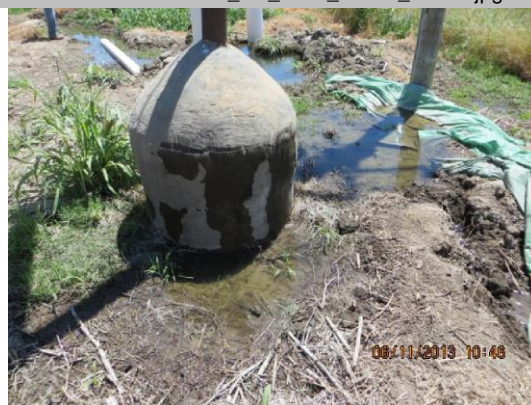
Photo 3 of 3 : UCIP_SP_2017_51450_24539.jpg

Leaks around standpipe on LS toe.

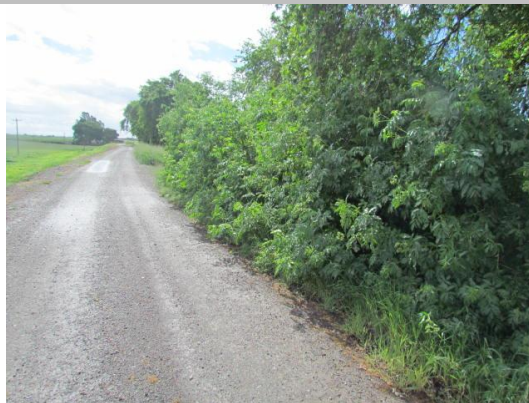
Photo 2 of 3 : SP_2017_RD0563_210_12_20170313_00012.jpg

Looking south at dense elderberry on waterward shoulder and slope. (Spring 2015)

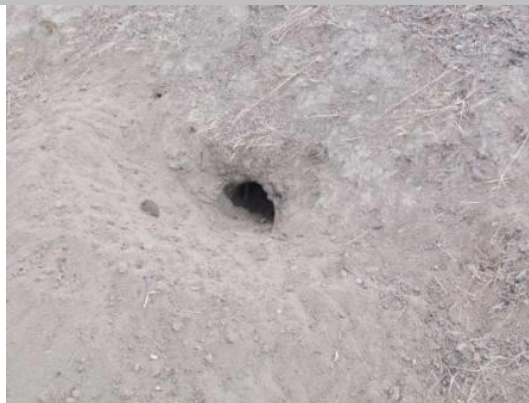
Photo 2 of 4 : SP_2017_RD0563_210_85_20170313_00082.jpg

Looking east at rodent hole on landside slope.

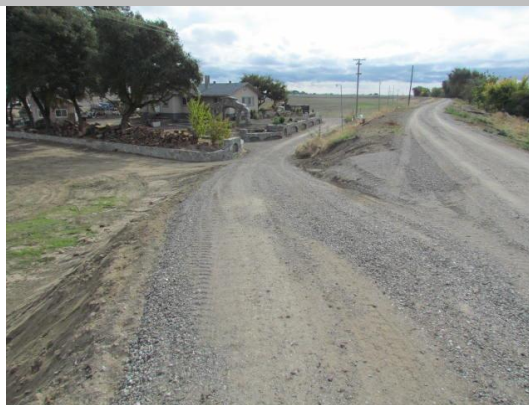
Photo 2 of 2 : SP_2017_RD0563_210_80_20170313_00079.jpg

Looking southeast at unauthorized ramp on landside slope.

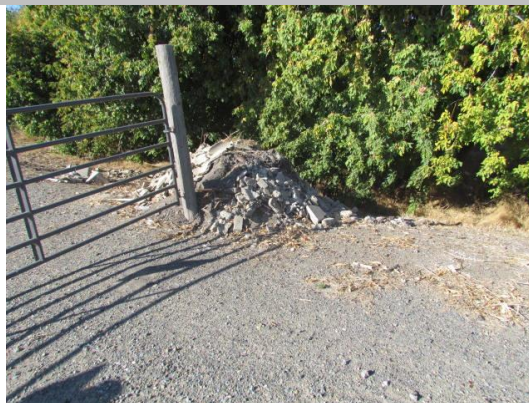
Photo 1 of 2 : SP_2017_RD0563_210_104_20170313_00105.jpg

Looking west at concrete rubble on waterward shoulder and slope.

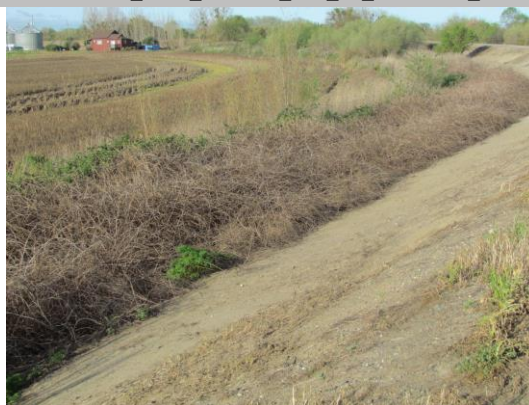
Photo 1 of 3 : SP_2017_RD0563_210_74_20170316_00250.jpg

Looking southeast at dead berryvines along landward toe and berm.
(Spring 2017)

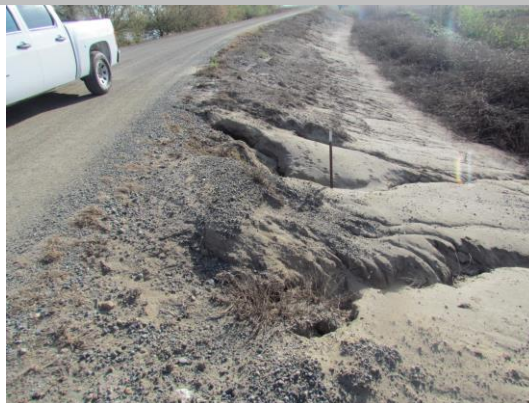
Photo 1 of 4 : SP_2017_RD0563_210_78_20170316_00251.jpg

Looking north at rain runoff erosion on landward slope. (Spring 2017)

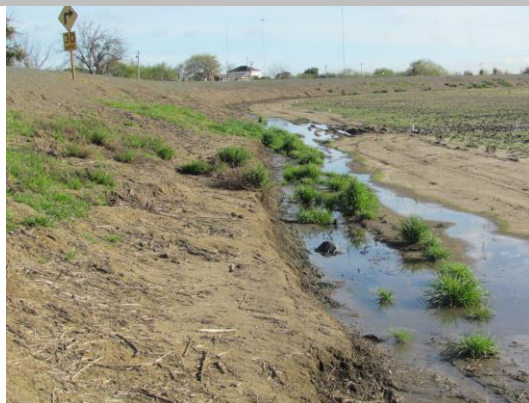
Photo 3 of 4 : SP_2017_RD0563_210_125_20170316_00252.jpg

Looking northwest at cut along farm's service road at landward toe.

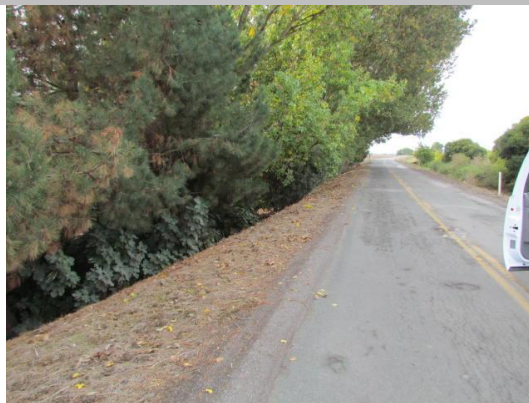
Photo 1 of 1 : SP_2017_RD0563_210_88_20170313_00086.jpg

Looking south at dense trees on landside slope and toe.

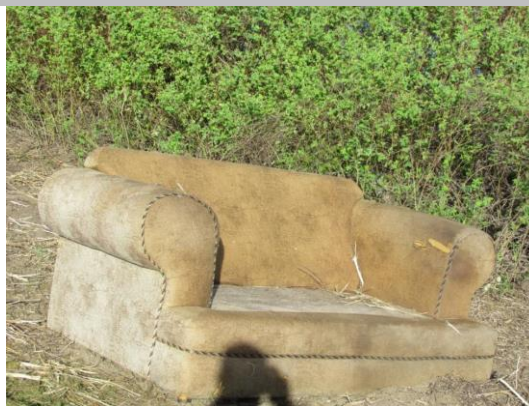
Photo 1 of 1 : SP_2017_RD0563_210_127_20170316_00257.jpg

Looking southwest at sofa on waterward slope.

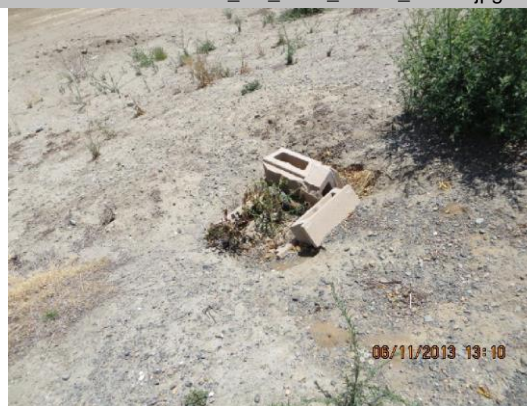
Photo 1 of 3 : UCIP_SP_2017_14950_24607.jpg

Vent/filler pipe exposed on LS shoulder.

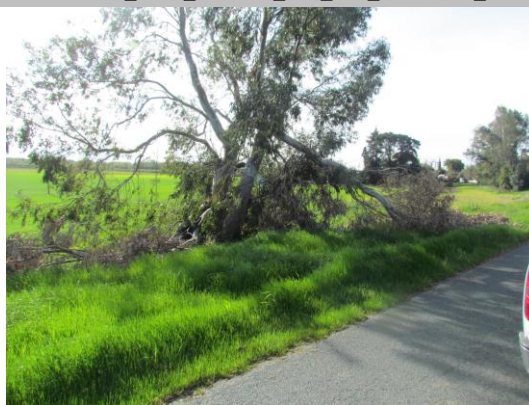
Photo 1 of 1 : SP_2017_RD0563_210_128_20170316_00258.jpg

Looking east at broken tree limbs on landward slope.

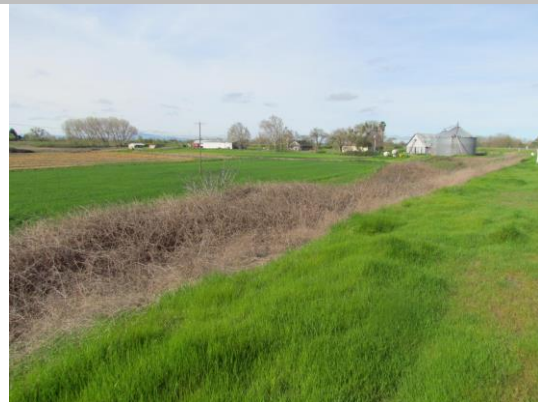
Photo 1 of 2 : SP_2017_RD0563_210_767_20170316_00259.jpg

Looking south at dead vines at landward toe. (Spring 2017)

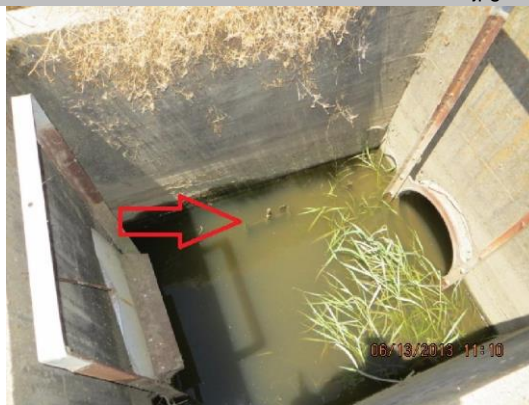
Photo 3 of 3 : UCIP_SP_2017_16292_27451.jpg

Broken slide gate in 7'X9' concrete distribution box on LS toe.

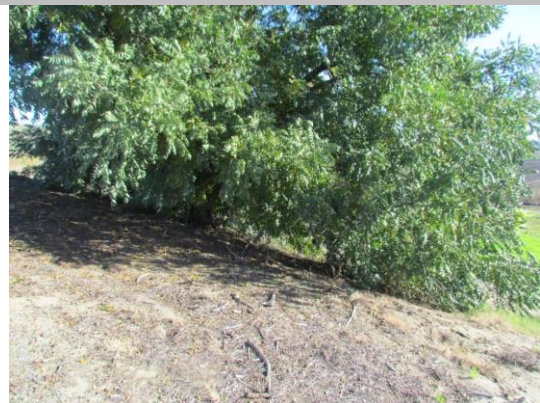
Photo 1 of 1 : SP_2017_RD0563_210_768_20170313_00152.jpg

Looking at untrimmed tree on landward slope.

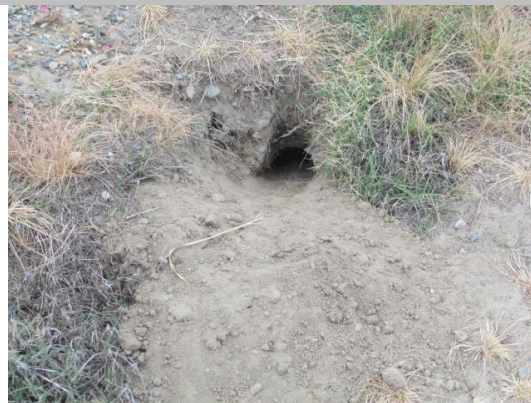
Photo 1 of 5 : SP_2017_RD0563_210_77_20170313_00068.jpg

Looking at typical rodent hole on landward slope. (Spring 2016)

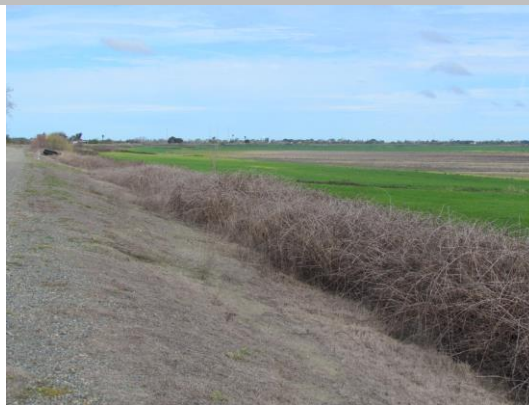
Photo 1 of 2 : SP_2017_RD0563_210_770_20170316_00262.jpg

Looking northeast at dead vines at landward toe. (Spring 2017)
